## SERVICE BULLETIN

TM-2550 DCL CALL SIGN DATA

2-7-86

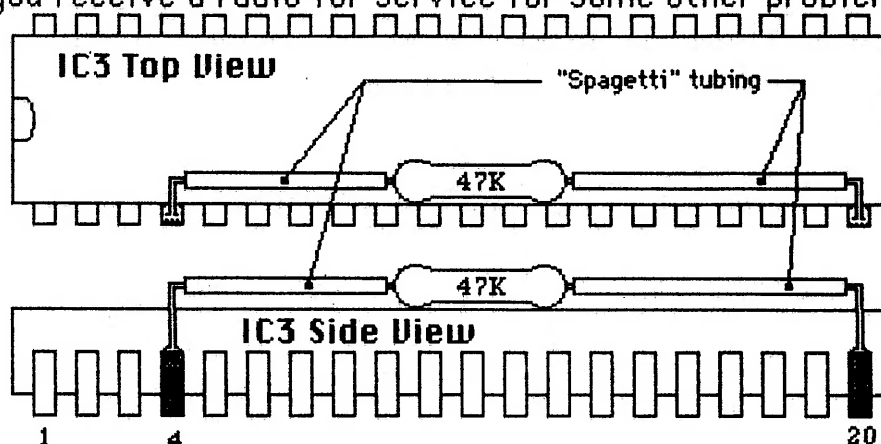
Some owners of the TM-2530/2550/2570 have reported a loss of the DCL system call sign data when the power switch is turned off. The call sign data actually remains in memory but timing prevents its utilization in some radios. Adding the resistor shown in the accompanying diagram corrects this problem.

If you receive a radio that exhibits this symptom add the resistor to IC3 the Slave CPU on the control unit (X53-1440-XX). Cover the resistor leads with "spaghetti" type insulation. Adding the resistor to radios that do not have this symptom will not cause any problems, so you may wish to add the resistor if you receive a radio for service for some other problem.

**Solder the 47K ohm resistor directly to pins 4 and 20 of IC3. Don't overheat or use too much solder. You must use an iron with voltage isolation on the tip!**

Before soldering unplug the DC Power cable and antenna from the radio. When soldering to this IC you must use a soldering iron that provides voltage isolation on the tip since IC3 is a CMOS device and can be easily damaged by static electricity or voltage on your iron. Use normal CMOS precautions. One final precaution: Don't bridge any of the pins on the IC with excess solder!
